DOT/FAA/AR-95/54

Transport Water Impact and Ditching Performance

March 1996

Final Report

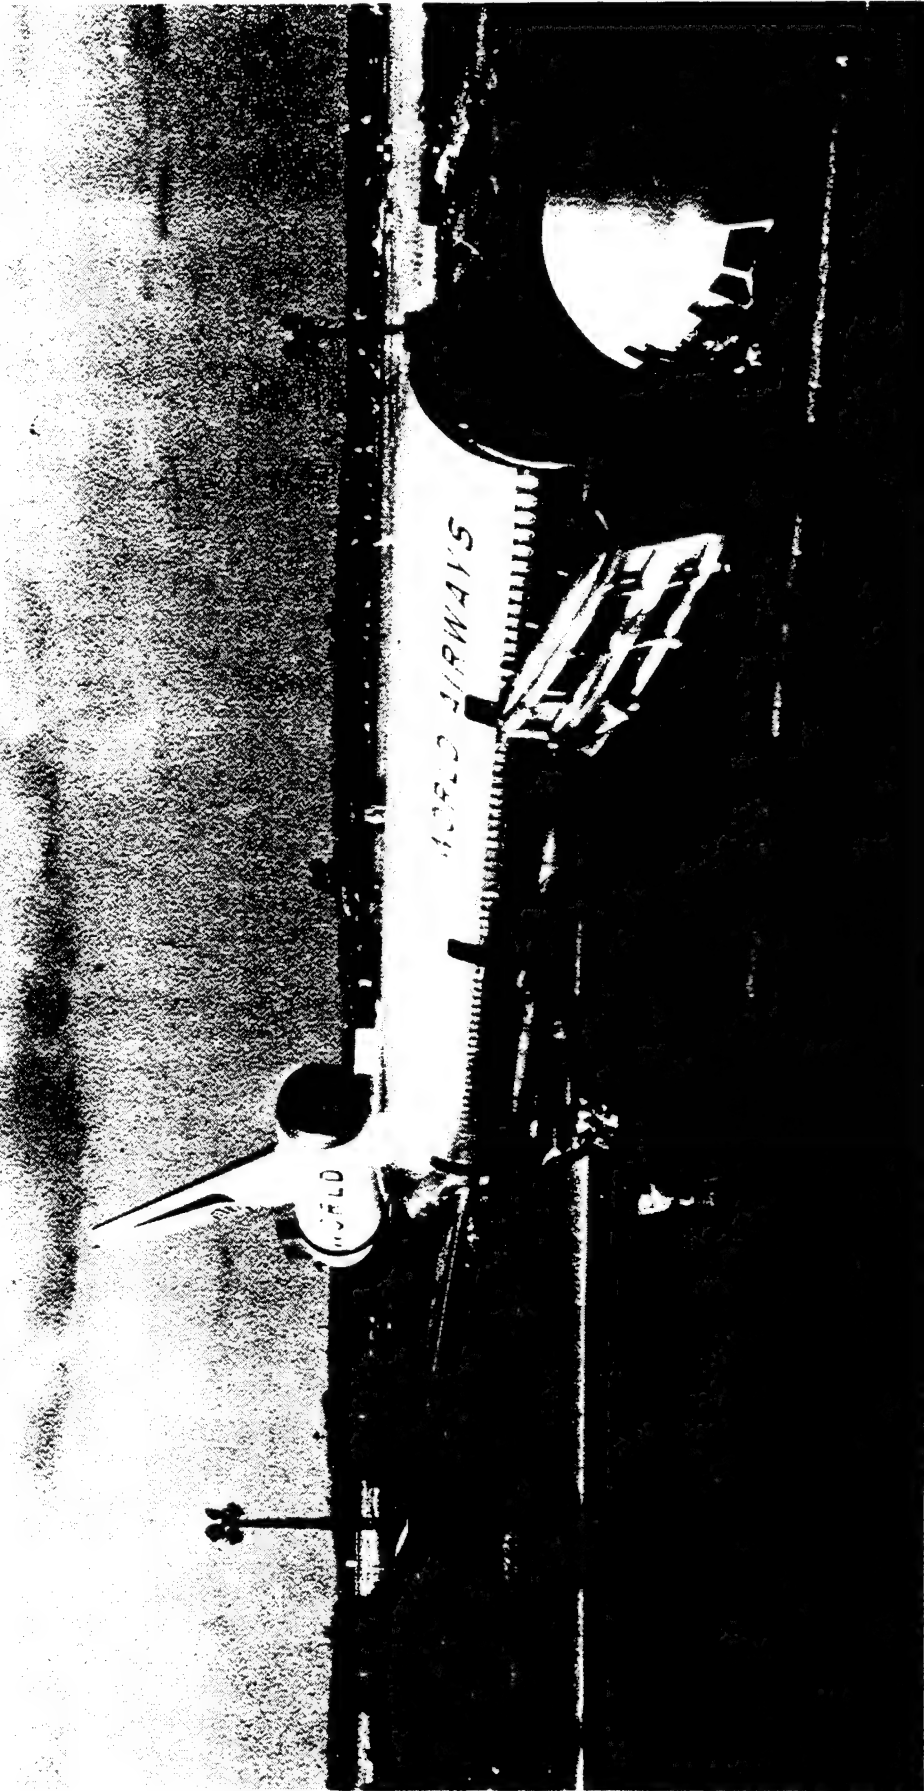
Upon crossing the end of the runway, the airplane came to rest with a slightly nosedown attitude in water which came up to the wings. A section of the nose up to the first row of the cabin seats separated along a fracture line (figure 1) and remained attached to the fuselage only by control cables and electric wire bundles. The pressure bulkhead was crushed along the fuselage bottom centerline, and the main cabin floor beams from fuselage station (FS) 392 to 475 failed due to the downward displacement. The pressure bulkhead at the forward end of the nose gear was crushed as well, leading to the failure of the extended nose gear. The main landing gear were extended and remained undamaged. The airplane's three engines remained attached to their respective pylons, although the No. 3 engine's rear mount was broken. There was no substantial mechanical damage to the engine.

FIGURE 1. WORLD AIRWAYS DC-10 AFTER COMING TO REST IN BOSTON HARBOR

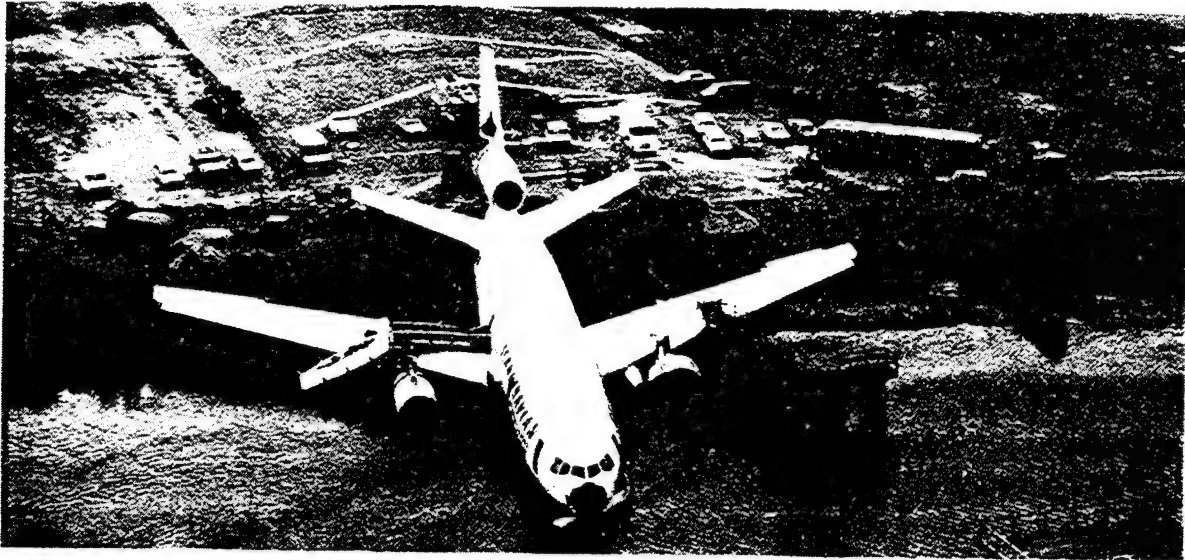
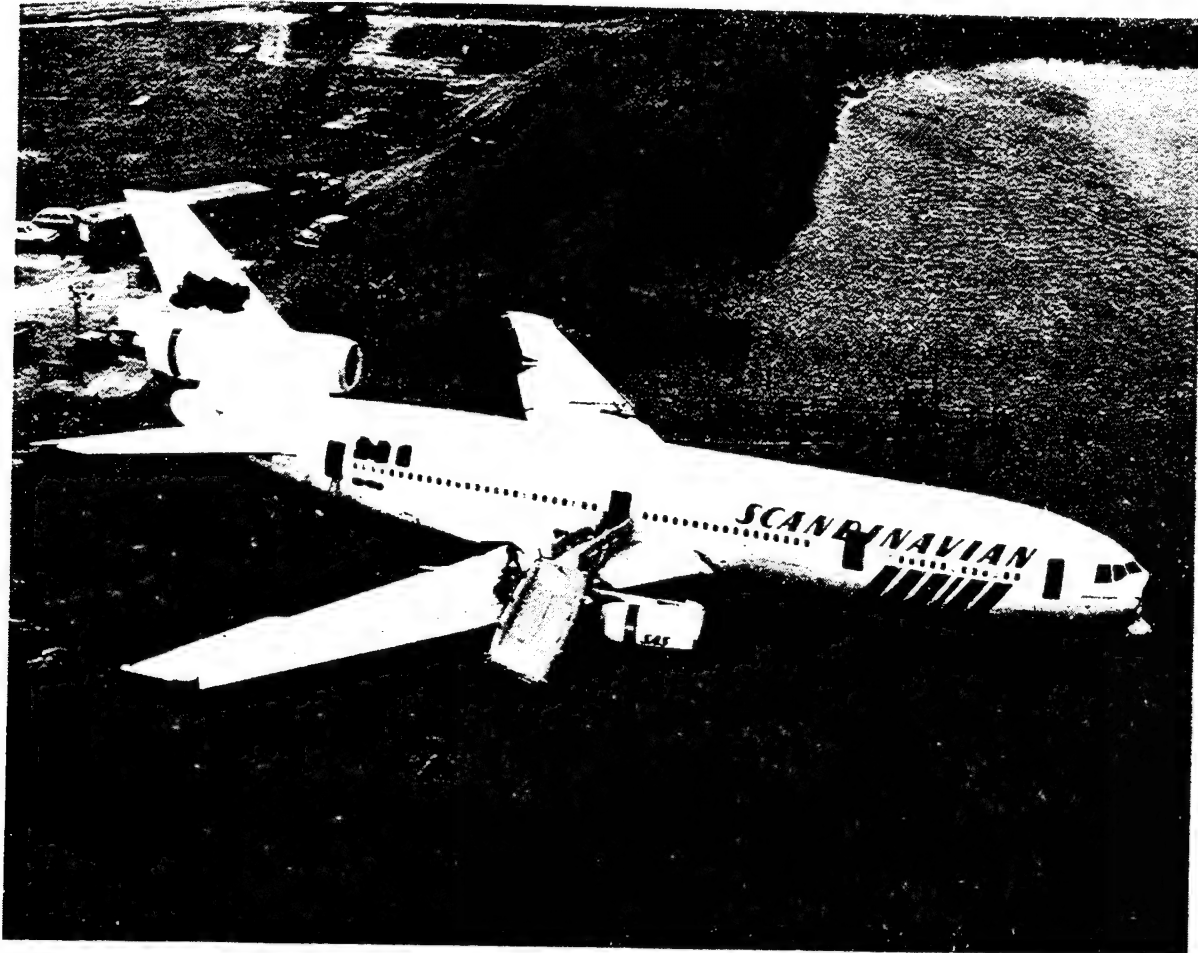
The nose of the airplane came to rest in the tidal waterway approximately 160 feet from the end of the runway overrun area (figure 2). The leading edge of the left wing was embedded in a wooden pier structure which supported the approach lighting system. The aft section of the airplane remained generally intact, however there was major damage to the lower nose area, to the radome, and to the forward pressure bulkhead at fuselage station (FS) 275. The damage was caused by hydrodynamic pressure generated during impact with the water.

FIGURE 2. JOHN F. KENNEDY AIRPORT RUNWAY GRADUAL SLOPE TO WATER

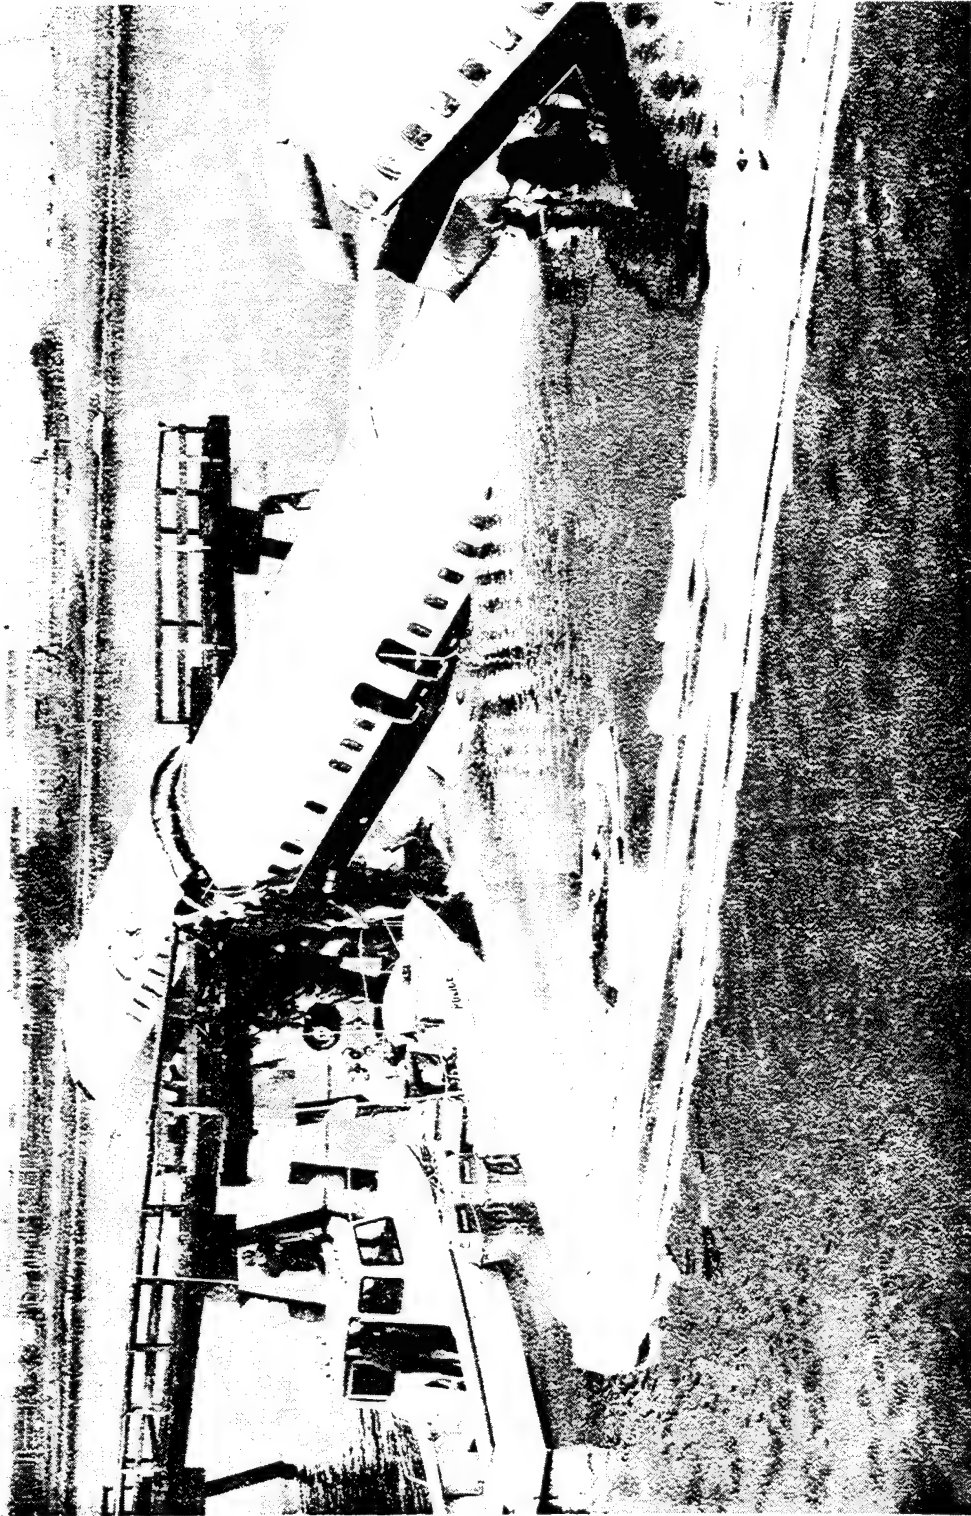
Floor displacement was the primary cause of two fatalities. Timber from the wooden approach light pier structure penetrated the fuselage and forced the floor section and surrounding seats upwards, crushing four passengers against the ceiling. Two passengers in row 21 were killed by asphyxia caused by compression of the chest and two passengers in row 22 sustained serious multiple injuries. A piece of wood also penetrated the forward cockpit bulkhead, but did not produce any seat dislocations and caused only minor injury to the captain. The airplane was equipped with eight exits (figure C-3): the L-1 main boarding door, the L-2 aft entry door, the R-1 forward galley door, the R-2 aft galley door, and four overwing exits. All exit doors, with the exception of the L-1 and L-2, were used during evacuation. The L-1 door could not be opened by the lead flight attendant, and the L-2 door was closed when water began entering the cabin. The R-1 slide was successfully deployed. The flight attendant disarmed the R-2 slide before the door was opened to prevent the slide from blocking the exit area. Both the left and right overwing exits operated successfully during evacuation.

FIGURE 3. US AIR B737-400 AFTER COMING TO REST ON LIGHTING STANCHION IN BOWERY BAY

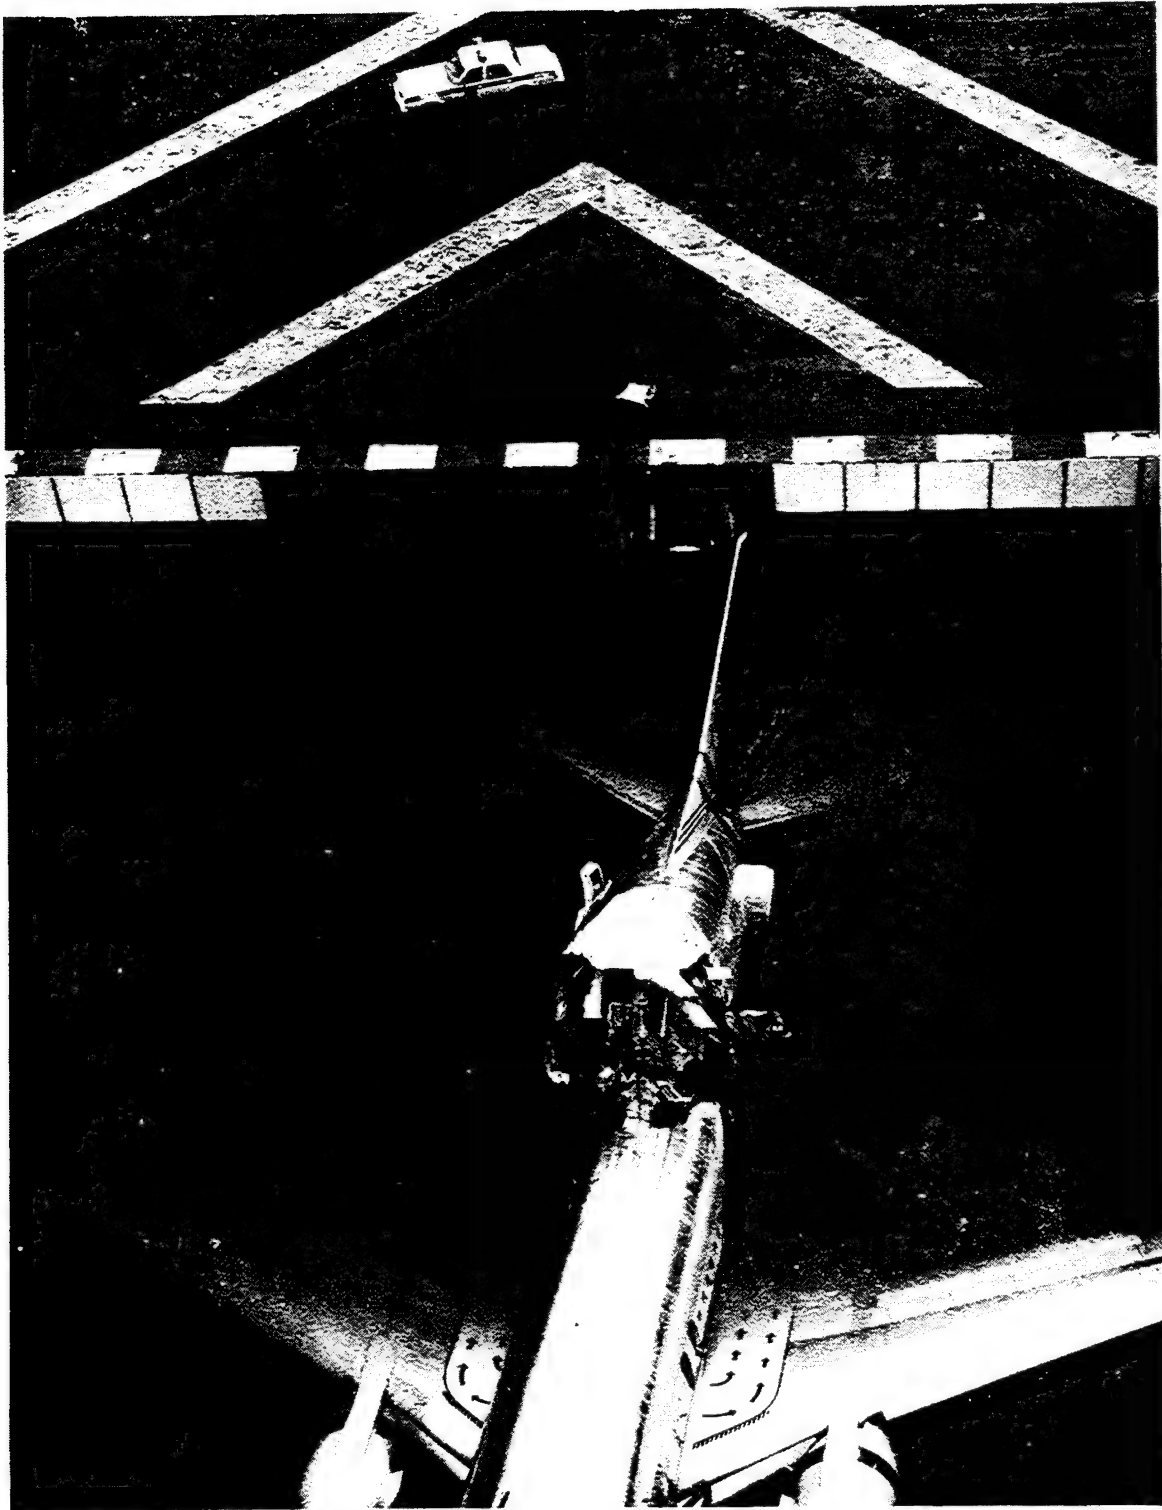
The drop into the water and the presence of obstructions immediately beyond the runway increase the potential for excessive impact forces on the airplane. The LaGuardia accident included both of these hazards. Upon crossing the end of the runway, the airplane encountered a drop of approximately 10 feet into the water and a concrete/wooden pier structure positioned within 50 feet of and in line with the end of the runway. The fuselage separated in two locations. In contrast, the JFK accident involved a very gradual slope into the water resulting in no fuselage separations. Although there was an approach lighting pier located directly beyond the runway, the landing gear remained on the ground and the pilot was able to swerve the airplane to avoid it.

FIGURE 5. LAGUARDIA AIRPORT RUNWAY DROP-OFF TO WATER

NTSB made the following recommendations to the Port Authority of New York and New Jersey. Survey the 1,000 by 500 foot surface area contiguous to the departure ends of the runways at the LaGuardia Airport in order to minimize hazards to airplanes that do not stop on the runways.
